EVAcharge SE Errata

chargebyte GmbH

Oct 26, 2023

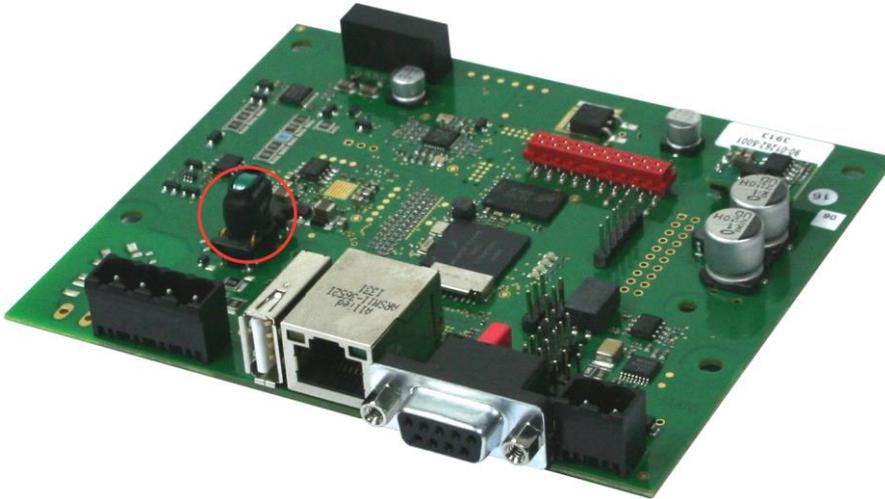
Figure 1 Location of the missing PLC Transformer

The quality control process of EVAcharge SE allowed that boards without PLC transformer (see red marked component in [figure 1](#)) were tested ok. When finding the error the delivery was stopped immediately - it was possible to determine the total number of defective boards. Two defective boards were delivered to customers.

The Powerline Communication will not work under most conditions, however it is possible that it works partially with a bad performance. SLAC will most probably always fail.

If a board was found, please send this EVAcharge SE back to your reseller or directly to in-tech smart charging. If you are able to solder the component to the board yourself, in-tech smart charging will provide you with the needed transformer immediately free of charge.

in-tech smart charging will improve the quality control process.

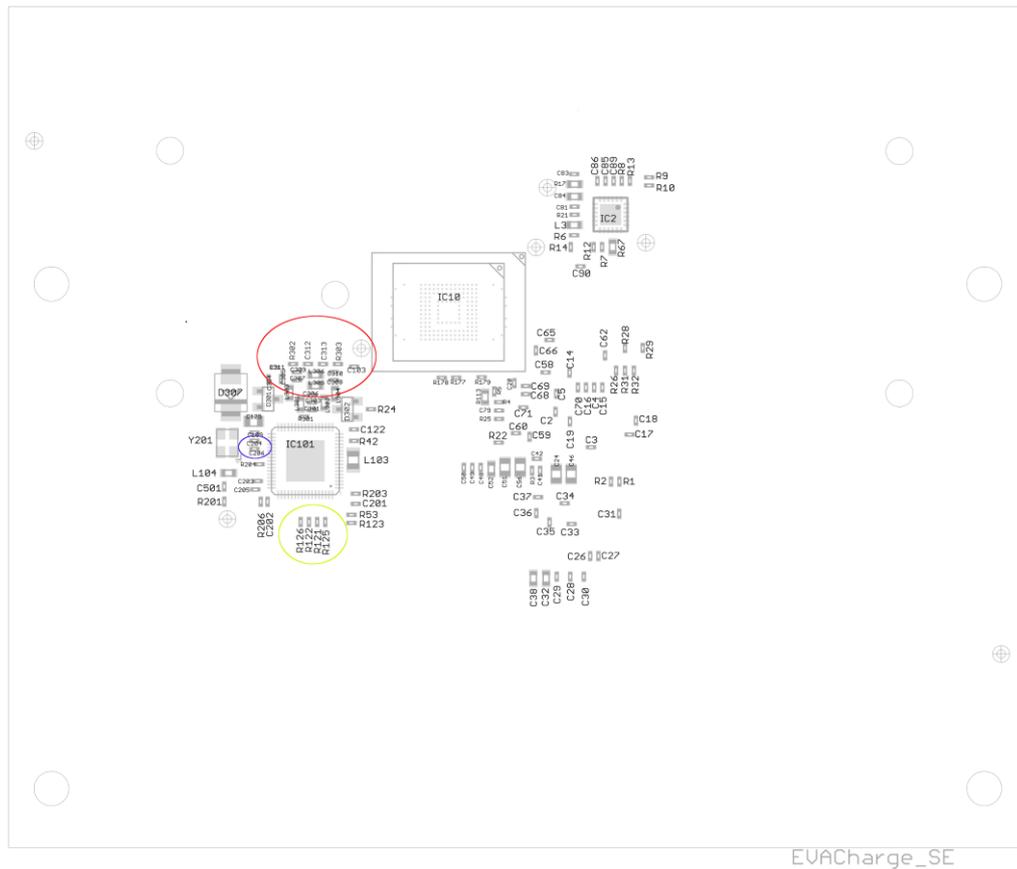
Figure 2 EVAcharge SE Bottom Placement for Errata #1, #2 and #3

The input attenuation of the powerline signal is too high. This results in bad results when the SLAC process measures the attenuation between EVAcharge SE and a counterpart (e.g. a PEV). Some units were reported to have loss of PLC connection due to this issue.

The bootmode of the QCA7000 PLC chip is set to host boot mode on some units. This would force the system to provide the chip with firmware and is not intended behaviour.

SLAC messages from PEV to EVSE and vice versa are not recognized and therefore the SLAC mechanism fails. The result is that EVSEs with affected EVAcharge SE devices will not be able to charge the PEV. The reason for the failure is an incorrect reference frequency of the HomePlug Green PHY chip. It needs 25 MHz with a tolerance of 23ppm over all conditions (ageing and temperature drift). This frequency is initially too high due to incorrect load capacitors. The capacitors need to be bigger in order to decrease the reference frequency of the oscillator.

To fully fix this errata two resistors need to be replaced. R302 and R303 have to be replaced by 24.9 Ohm in 0402 - see [figure 2](#), red area.

To fully fix this errata one resistor needs to be removed while another one needs to be added. R126 (10K, 0402) needs to be removed, R122 needs to be populated with 10 kOhm in 0402 - see [figure 2](#), green area.

To fully fix this errata two capacitors need to be replaced. C204 and C206 need to be replaced by 20 pF, package 0402, dielectric: COG/NP0 - see [figure 2](#), blue area.
